TECHNICAL REPORT REMR-CO-16

AD-A229 927 AND JETTIES BY VOID SEALING: SUMMARY REPORT

Coastal Engineering Research Center

October 1990 Final Report

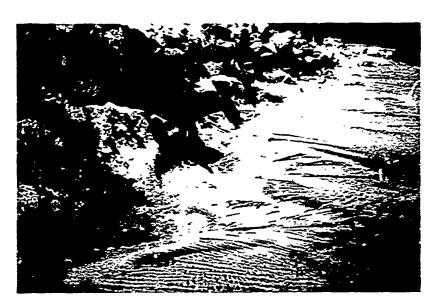
Figure 1. Prototype field evidence of sand transport through rubble-mound breakwater or jetty

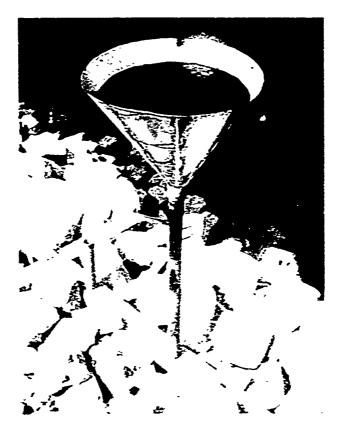
Figure 30. Funnel filled with Sand-Asphaltic Mixture of sealant for injection into physical model of rubble-mound structure

284. It was not known if cooling of the mixture as it was deposited in the pipe through the water column, frictional resistance of the sandy mixture, or combinations of both prevented the placement. Therefore, injecting mastic with no solids was next attempted. Five gallons of AC-30 asphalt was heated to 400° F and poured into the closed funnel (Figure 31). For this test, the

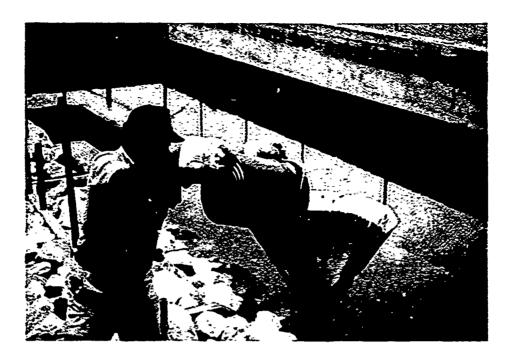
Figure 31. Heated Mastic Asphalt being poured into funnel for injection into physical model of rubble-mound structure

funnel was connected to the pipe in Hole E3. The bottom of the pipe was located 2.8 ft above the sump floor. At the time of placement, the asphalt temperature was 335° F. When the bottom closure device was removed, there was considerable bubbling of asphalt in the funnel, with minor loss out of the funnel, but all the asphalt in the funnel drained down the hole in about 10 sec. Only a small amount of steam was visible during this operation.

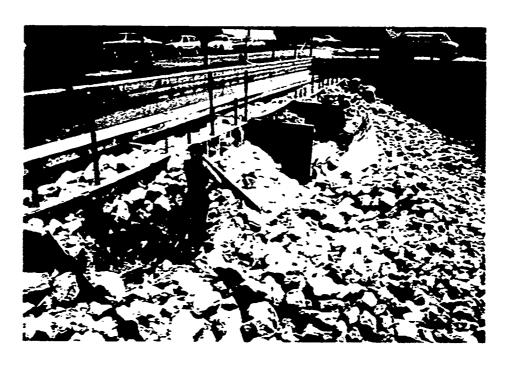
Figure 34. Disassembly of physical model section for evaluation of Sand-Asphaltic Mixture as potential material for veid sealing

294. No trace of the Sand-Asphaltic Mixture of sealant was found in the structure. It was concluded that the material traveled no farther than the lower end of the pipe and did not actually penetrate any voids. AC-30 mastic,

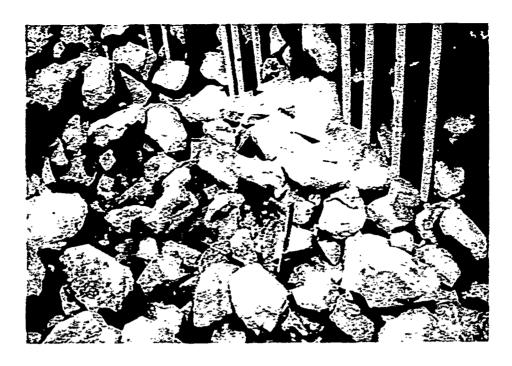
289. The WES Mixture of cementitious sealant pumped into Section A with excessive amounts of water created the hardened mass shown in Figures 36 (Phase 1) and 37 (Phase 2). Continuity of the sealant between Holes A3 and A4 was good, a distance of 3.5 ft. The sealant was sufficiently cohesive to build a mass 1 ft higher than the injection point elevation in Hole A3. Because of the spread from that hole, the material injected in the adjacent Hole A4 built up about 2 ft higher than the injection level. Spread of the mixture was about 3 ft laterally from the injection pipe and created an oblate spheroidal shape. Completeness of sealing the individual voids was very good. In the set condition, the material was very hard. Bond strength was very good. In attempting to dislodge a stone with a sledge hammer, the stone split before it would be loosened, creating a dramatically impressive scene on the videotape. No mixture injected in Hole A2 could be found in the structure. The material was probably washed out by the increasing amounts of water added at the pump as the last amount of the batch was being placed.

Figure 36. Section A, Phase 1 disassembly. (WES Mixture of cementitious sealant placed by W. G. Jaques Company, Des Moines, IA)

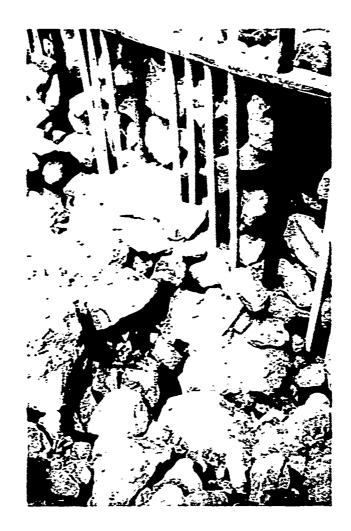
Figure 37. Section A, Phase 2 disassembly. (WES Mixture of cementitious sealant placed by W. G. Jaques Company, Des Moines, IA)

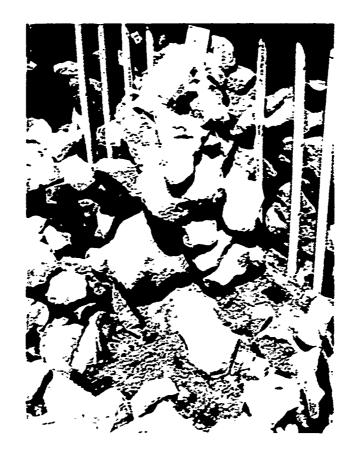
290. A columnar structure resulted in Section B from placing the WES Mixture, which was proportioned exactly as specified. The hardened mass was about 3 ft in diameter and extended to elevation 5 ft, which was 0.5 ft higher than the injection level, as shown in Figures 38 (Phase 1) and 39 (Phase 2). The lateral penetration was good, with the sealant entering nearly all the voids in the injected structure region. Using the above dimensions and an estimated void ratio of 35 percent, the WES Mixture of cementitious sealant filled one-half of the void space of the cemented mass. It was an extremely competent sealant, and its bonding to the rocks was very good.

Figure 38. Section B, Phase 1 disassembly. (WES Mixture of cementitious sealant placed by WES Structures Laboratory)

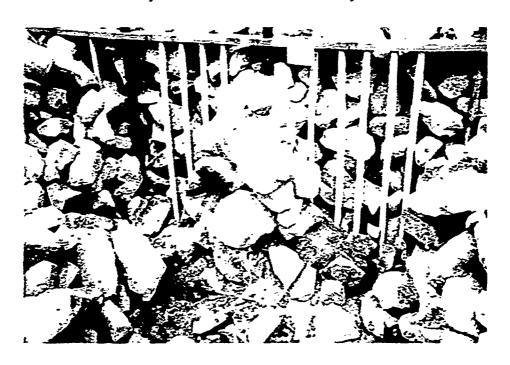
Figure 39. Section B. Phase 2 disassembly. (WES Mixture of cementitious sealant placed by WES Structures Laboratory)

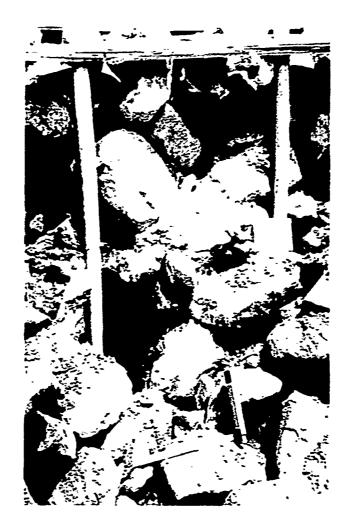
292. The Sodium Silicate-Cement Mixture of chemical sealant injected into Section C did not form the continuously sealed mass with high integrity as anticipated, shown in Figures 42 (Phase 1) and 43 (Phase 2). At higher elevations within the structure, sealant could be found only on horizontal surfaces and in isolated voids. Pockets of sealant were not firmly set; it could be easily squeezed through the researcher's fingers. This was an indication that penetration was good, but that interference had occurred with the mixing of the components of the sealant or with its gelation in the section. Water in this enclosed section had been circulated in order to create a uniform salinity, and the mixing action suspended a high concentration of fine material and may have affected the reaction of the components. The set time of the sodium silicate-cement sealant placed into the structure was 50 to 60 sec. This section was found to be completely porous.

Figure 42. Section C, Phase 1 disassembly. (Sodium Silicate-Cement Mixture of chemical sealant placed by W. G. Jaques Company,

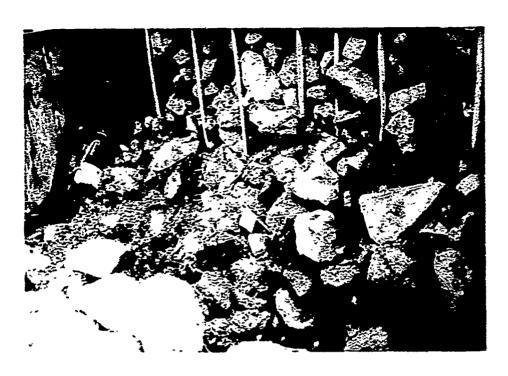
Figure 43. Section C, Phase 2 disassembly. (Sodium Silicate-Cement Mixture of chemical sealant placed by W. G. Jaques Company, Des Moines, IA)

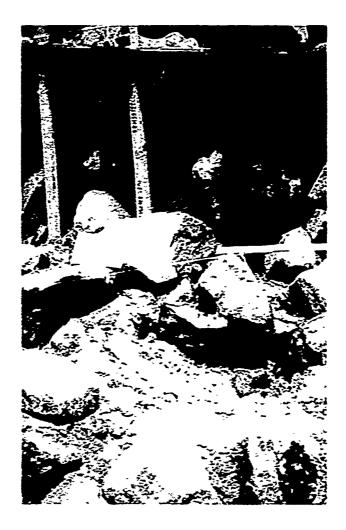
293. The Sodium Silicate-Diacetin Mixture of chemical sealant injected in Section D did not solidify the sand into which it had been injected, as shown in Figures 44 (Phase 1) and 45 (Phase 2). While dismantling the section, traces of the dye could be found in the sand, sometimes at distances of 3 ft from the injection pipe, but the sand had no characteristics of actually being sealed. Farther than 6 in. from the injection pipe, sodium silicate was present in only trace amounts in the sand. The set time of this sealant was about 15 min. Results indicate that the set time should have been about half that duration. Bond strength was essentially zero, except in localized areas around Hole D3. A pocket of neat sealant was found at the upper level of the sand layer of the section, and it may have resulted from a flow channel being created adjacent to the outside of the injection pipe during sealing of the first lift (Figure 45). A thin layer of sodium silicate covered the sump floor beyond the structure (Figure 46).

Figure 44. Section D. Phase 1 disassembly. (Sodium Silicate-Diacetin Mixture for sand stabilization placed by W. G. Jaques Company. Des Moines.IA)

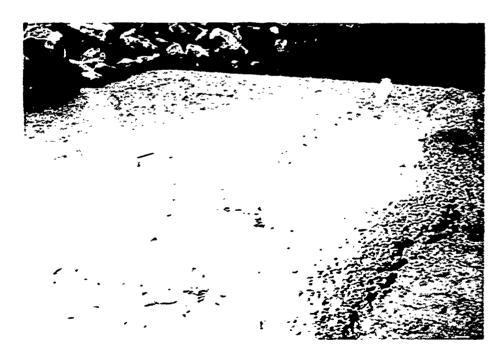
Figure 46. Layer of Sodium Silicate-Diacetin Mixture on sump floor which was not retained within the sand layer

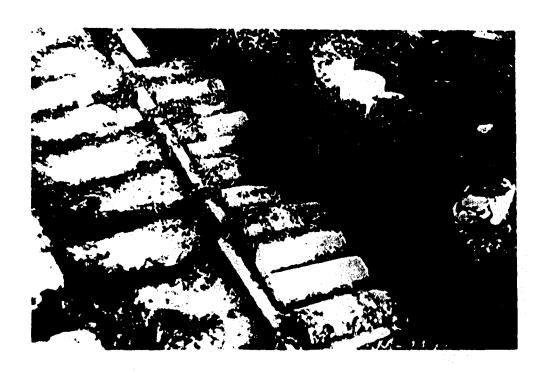
Figure 52. Cementitious and asphaltic sealant specimens at mean water line after 26 months exposure, Treat Island, ME

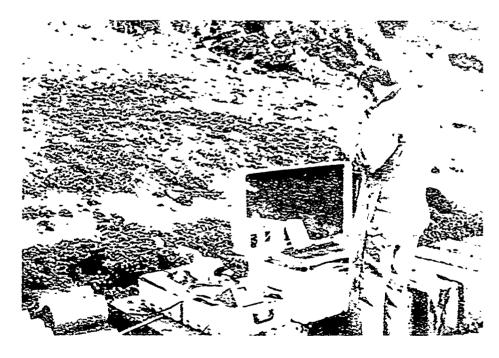
- 337. Figures 52 through 56 show the condition of some of these specimens when they were retrieved and retested in September 1989, after having been exposed to the environment for 26 months. The storage arrangement and all specimens were completely covered by sediment and marine plant growth, which, in turn, provided habitat for coldwater marine animals. All cementitious specimens were in good condition. The sodium silicate chemical

Figure 35. WES Structures Laboratory employee retesting cementitions scalar, specimens at mean waterline, Treat Island, MF

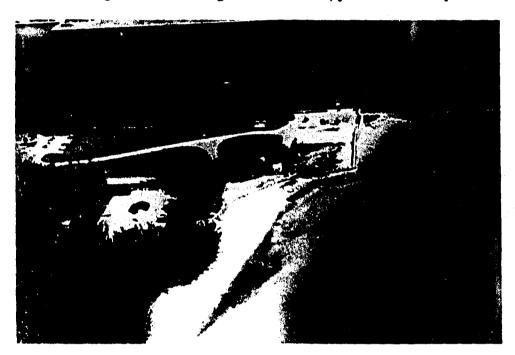
346. Shoreline recession for the 2-mile reach immediately south of the entrance channel (Figure 73) averaged about 5 ft/year for the period 1929 to

Figure 73. John U. Lloyd State Park immediately south of entrance channel to Port Everglades, FL, site of continual beach erosion

1961 (BCEQCB 1986). From 1961 to 1965, compatible dredged material from the entrance channel was placed on the south beach (county-owned at that time), totaling approximately 729,000 cu yd. In late 1976 and early 1977, a beach fill consisting of 1,090,000 cu yd of material dredged from borrow sites located 2 miles offshore of the south beach was placed along the 1.5-mile section of John U. Lloyd State Park (BCEQCB 1986). The beach-fill shoreline retreated at an average rate of 13 ft/year from 1978 through 1985 with the greatest losses occurring along the 4,000-ft section south of the south jetty. No material from the 1984 channel deepening was placed on the south beach. During site visits conducted in the present study, the south beach was observed to have a scarp approximately 6 ft in height. The high erosion rate

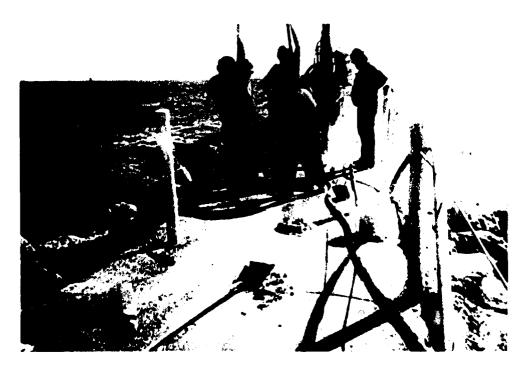
Figure 80. Drilling south jetty at entrance to Port Everglades, FL

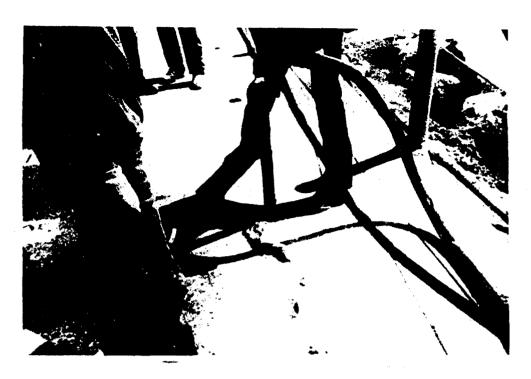
Figure 83. Injecting sodium silicate-cement sealant during sealing south jetty at entrance to Port Everglades, ${\sf FL}$
